#### **TECHNICAL REPORT M1**

# SEDIMENTATION STUDY OF THE MISSISSIPPI RIVER SANTE FE CHUTE, DOOLAN CHUTE HYDRAULIC MICRO MODEL INVESTIGATION

Final Report

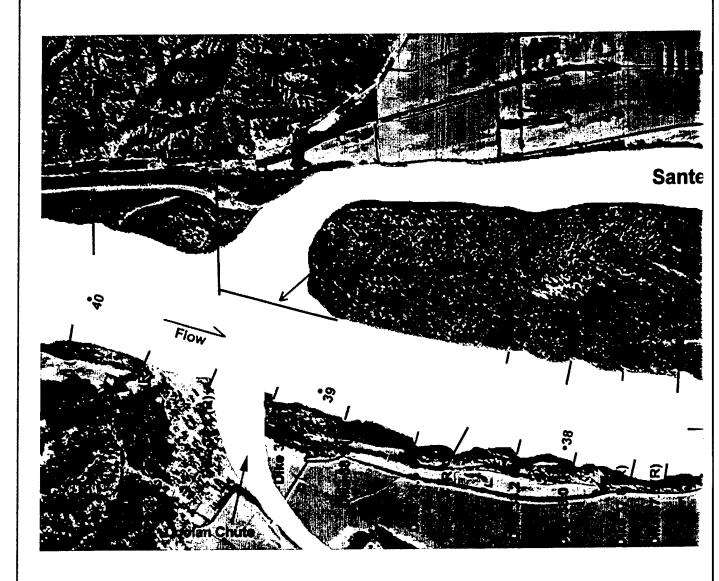
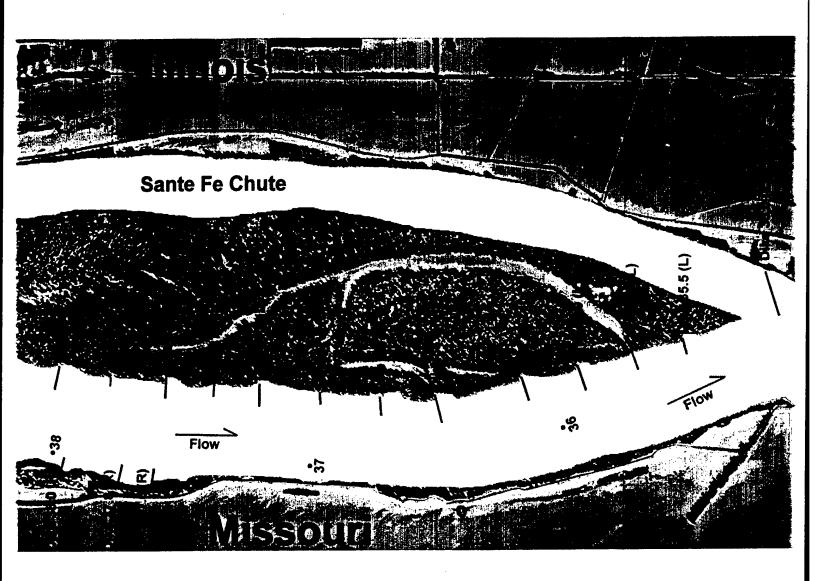
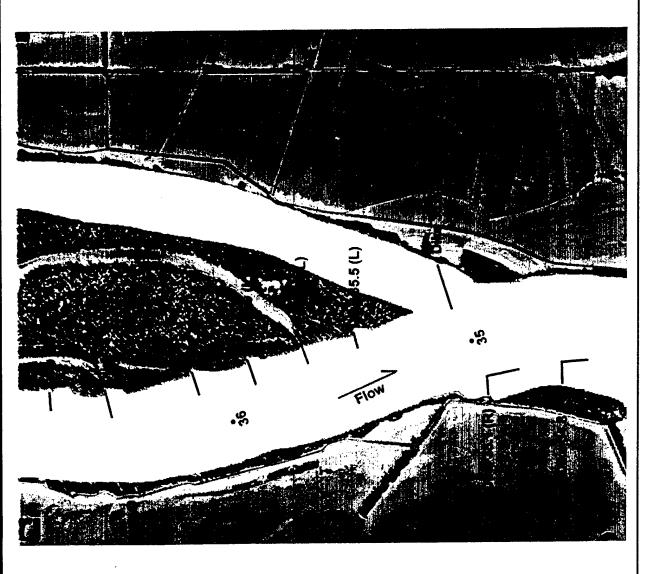
HAH	U.S. ARMY ENGINEER DISTRICT, ST. LOUIS CORPS OF ENGINEERS ST. LOUIS, MISSOURI	
PRIEPARED BY: R. Hwitick CHECKED BY: R. Davisroy DATE: 29 July 1995	Sante Fe/Doolan Chute Micro-Model Study Mississippi River Miles 40 - 35  Photograph of Sante Fe Study Reach	
-	PLATE NO 1

Plate 1 is a map depicting the characteristics, configuration, and nomenclature of the Mississippi River, miles 40 to 35. The upper end of Sante Fe Chute begins at River Mile 39.7L. This side channel parallels the main channel for a distance of approximately 5 miles. Doolan Chute begins at river mile 39.0R and re-enters the main channel at river mile 31.0R.

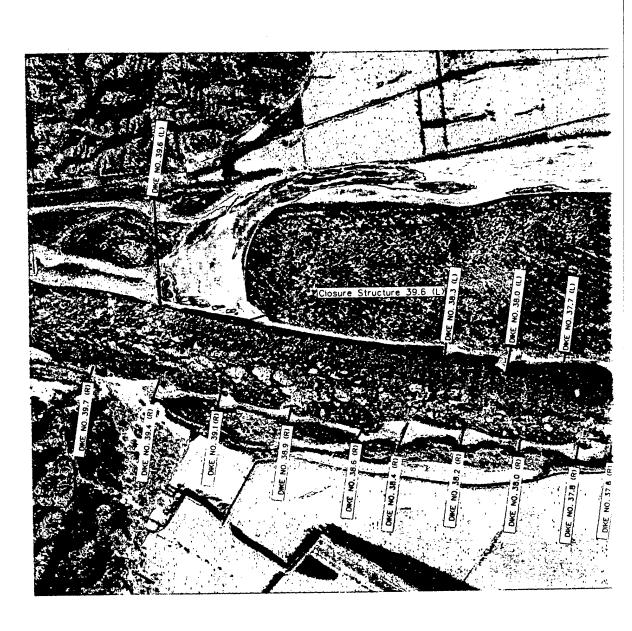
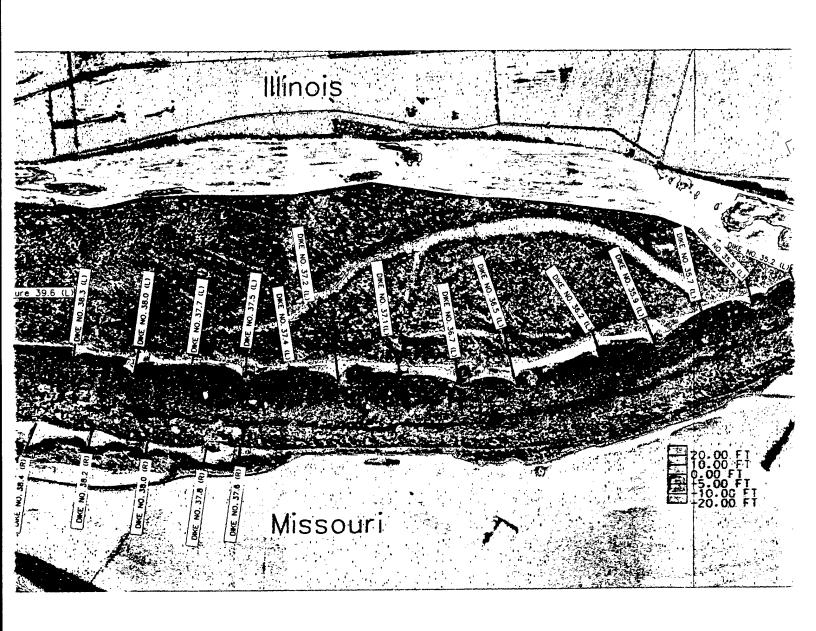
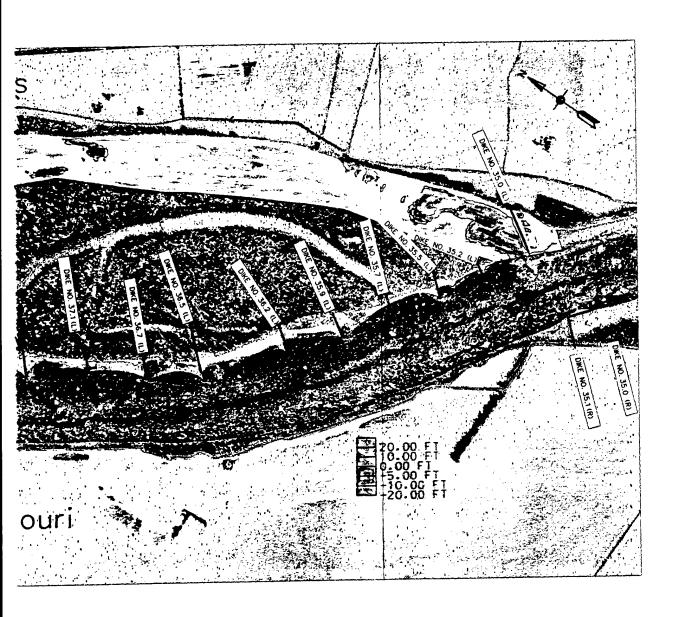
In 1992, river engineers of the St. Louis District made an inspection of this chute and noted, as verified by the 1995 survey, that there were minimal water depths throughout most of Sante Fe Chute. The jet boat used for inspection drew approximately 6 inches of draft and had a very difficult time navigating in the chute. Several times the jet boat touched bottom. Engineers observed that for the most part, the left descending bank of the chute was erosional and vertical.

Several prototype surveys were used to determine the general bed characteristics that existed in the prototype (Plates 2, 8, and 9). A 1994 low water ice photograph of the study reach of the Mississippi River was also used to compare surface flowlines (Plate 12).

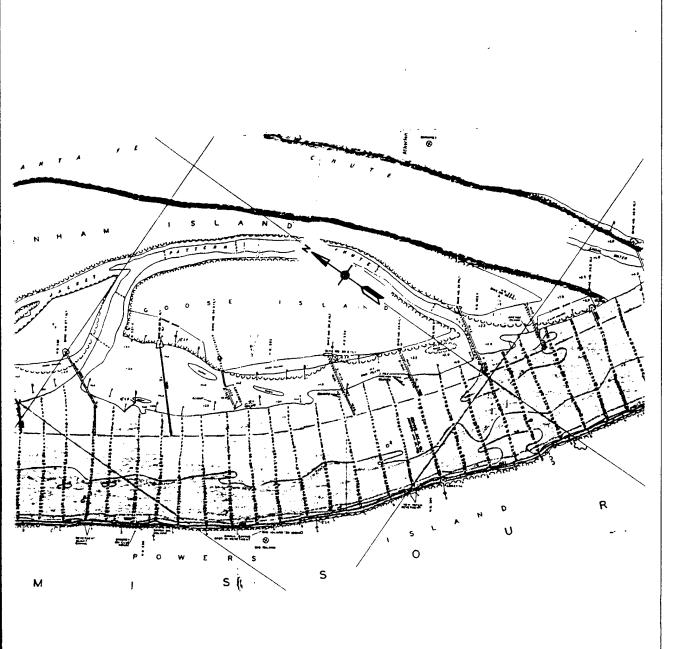
1958 PROTOTYPE SURVEY

Plate 3 depicts the historical condition of the chute in 1958. The entrance of the chute occurred on the right descending bank at mile 38.9. The entrance width was approximately 600 feet. The channel depth in this area was approximately 0 feet relative to the Low Water Reference Plane (LWRP), or approximately +5 at the Cape Girardeau gage. Although vegetation markings in the chute just

The width of the historical chute varied from as little as 200 feet at the lower end to as wide as 300 feet. A conservative estimate on the average width was approximately 250 feet, which is very similar to the present day chute width.

Little is known of the depths of the historical channel, although indications at the entrance and exit conditions from the hydrographic survey indicate that the chute, at least in these areas, was relatively shallow. It is assumed that the elevation of the banks of Doolan Chute was approximately the height of the banks of the main channel, or approximately a +30 LWRP, as indicated from the 1958 survey.

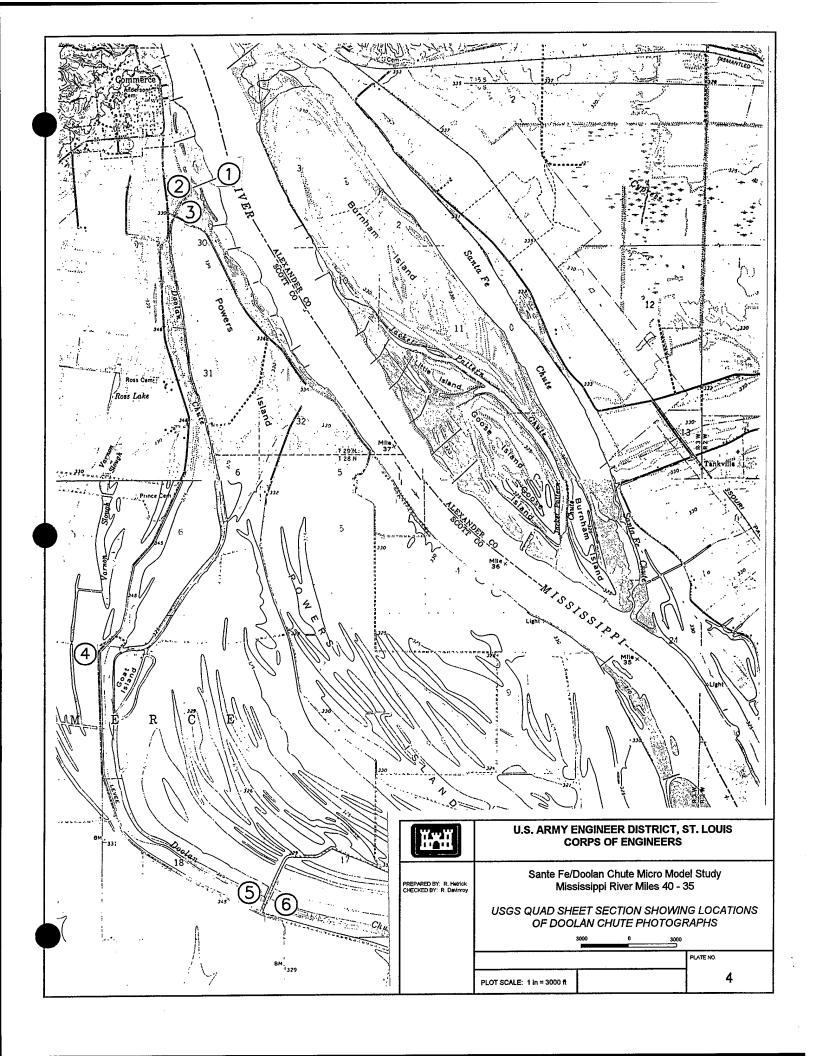
A site investigation of Doolan Chute was conducted by Robert Hetrick during the week of 19 February to gain a better understanding of the present day conditions of the chute remnants. Plate 4 is a USGS quad sheet of the Doolan Chute area. This map shows the locations of the photographs taken in the field. Remnants of Doolan Chute still exist today. Although the chute is no longer attached to the main channel, approximately 70 percent of the original reach still exists.

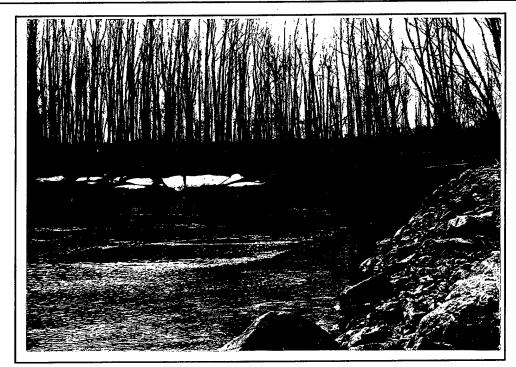
Photograph #1; Doolan Chute

From the tip of dike 39.1, as shown on Plate 5 (Photograph #1), there was no indication of any chute. The bankline was constant across this section, as well as the density and age of the vegetation. Approximately 300 feet inland of the

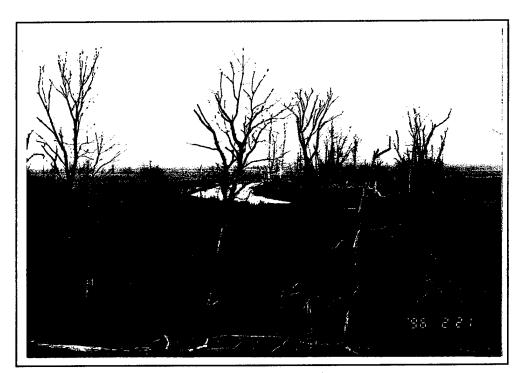
Photograph #4; Doolan Chute

The lower photograph on Plate 6 (Photograph #4) was taken from the levee looking upstream along the northern section of Goat Island. The chute contained a defined channel that was approximately 75-100 feet in width. The transition from the poorly defined channel to the well defined channel occurred approximately ½ to ¾ mile upstream of Goat Island.

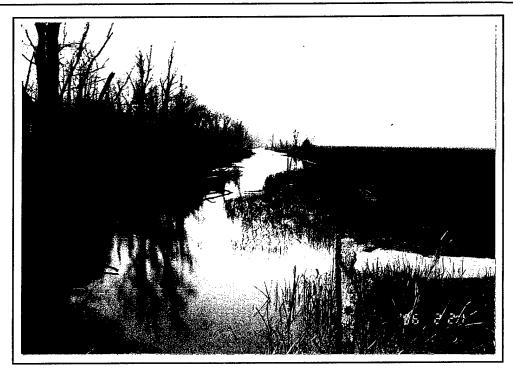
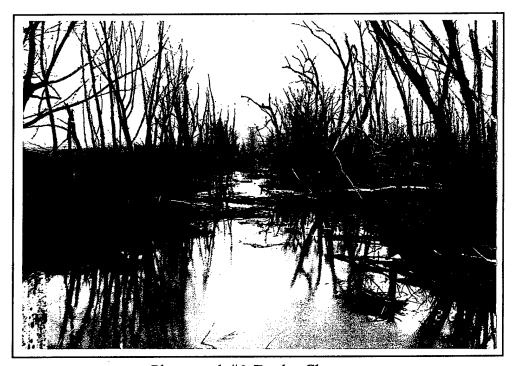
II.X.II	U.S. ARMY ENGINEER DISTRICT, ST. LOUIS CORPS OF ENGINEERS ST. LOUIS, MISSOURI		
PREPARED BY: R. Hetrick CHECKED BY: R. Davinroy		Sante Fe/Doolan Chute Micro Model Study Mississippi River Miles 40 - 35	
	Photographs #5 and #6 of Doolan Chute		
-		PLATE NO.	
		7

The photographs on Plate 7 (Photographs #5 and #6) were taken looking upstream and downstream, respectively, from the road that crossed Doolan Chute, approximately 2 miles downstream of Goat Island. The photographs show the typical channel characteristics that were present between Goat Island and the road crossing. At the road crossing, there was an 8-10 foot diameter steel culvert.

The chute downstream of the culvert contained a well defined channel similar to the channel upstream. This defined channel continued downstream to the confluence with the main channel of the Mississippi River.

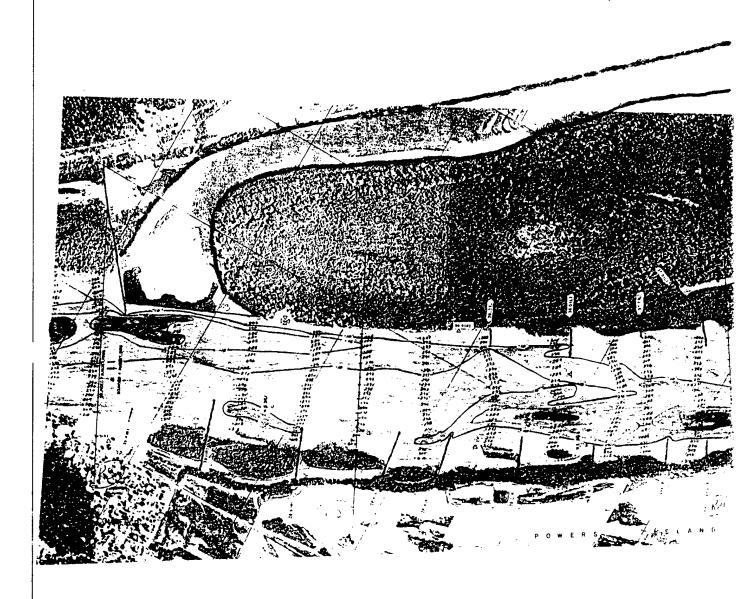
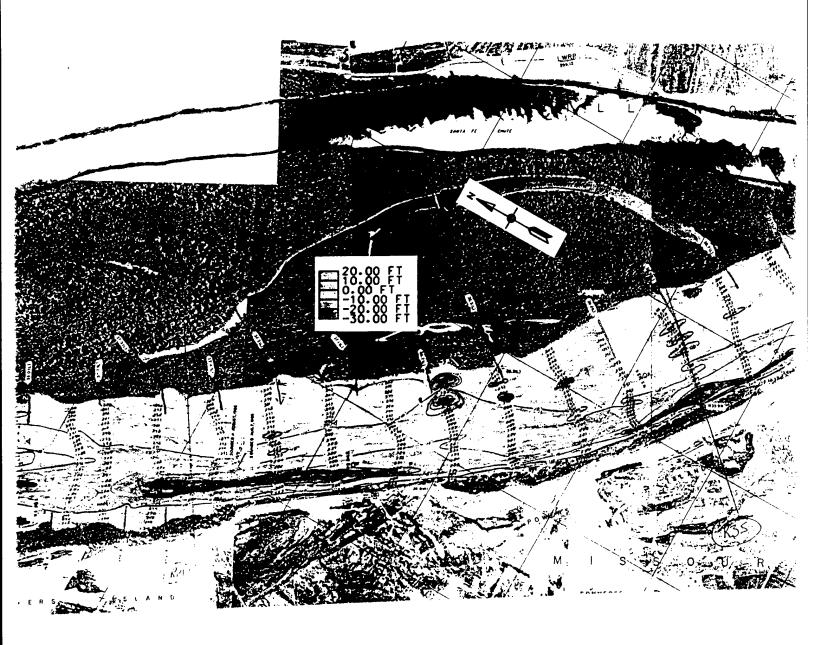
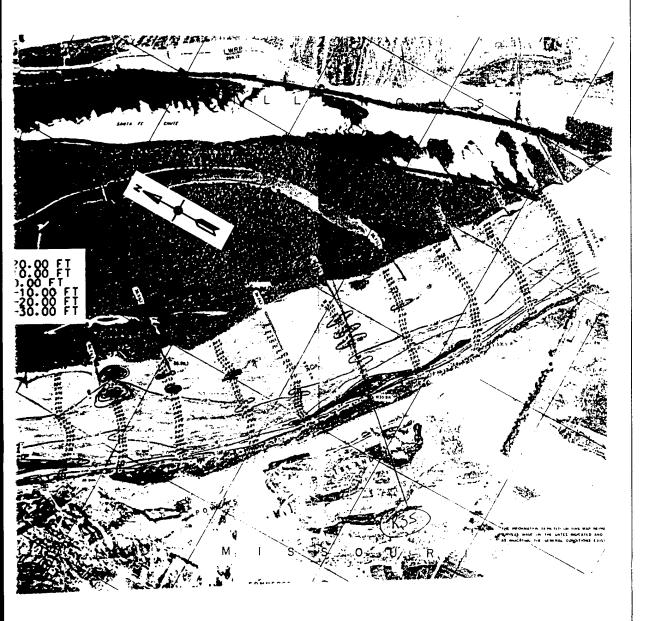
H-H	U.S. ARMY ENGINEER DISTRICT, ST. LOUIS CORPS OF ENGINEERS ST. LOUIS, MISSOURI
	Sante Fe/Doolan Chute Micro Model Study Mississippi River Miles 40 - 35
	1986 PROTOTYPE SURVEY
	1000 11
	PLATE NC B

Plates 8 and 9 are 1986 and 1993 plan view hydrographic survey maps of the Mississippi River main channel. At River Mile 40, a crossing existed with navigation depths averaging between -15 to -20 feet LWRP. The channel transitioned to the left descending bank adjacent and just parallel to the closure structure at mile 39.4L. The depths varied between -20 and -50 feet LWRP, depending upon which survey was used (it must be noted that the survey of 1993 was a high water survey, while the survey of 1986 was a low water survey).

The channel remained against the left descending bank until approximately mile 38.3, where it transitioned to the right descending bank. Depths in this area were between -10 and -15 feet LWRP. The channel remained against the right descending bank through the study reach, forming a long bendway channel. With exception, one particular dike on the left descending bank at Mile 36.7L produced a scour hole in excess of -30 feet LWRP (1986 survey).

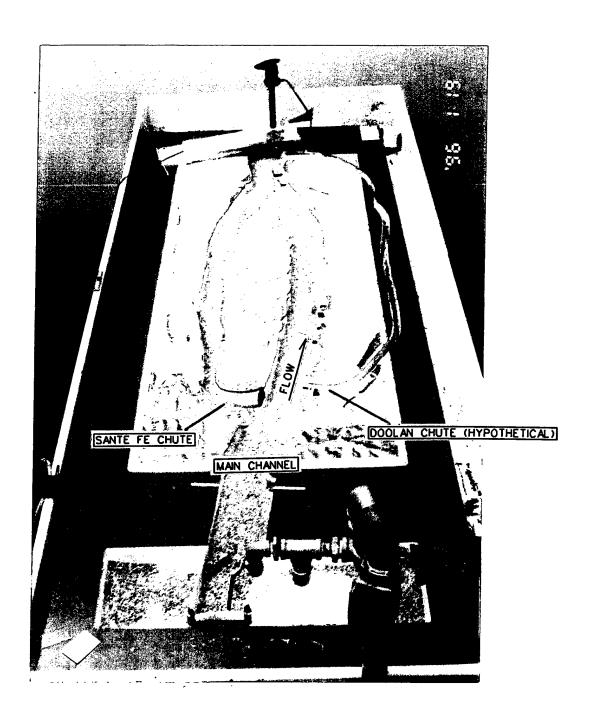
HXH	U.S. ARMY ENGINEER DISTRICT, ST. LOUIS CORPS OF ENGINEERS ST. LOUIS, MISSOURI		
PREPARED BY: R. Hetrick CHECKED BY: R. Devinroy	Sante Fe/Doolan Chute Micro Model Study Mississippi River Miles 40 - 35		
	Photograph of Sante Fe Chute Micro Model		
-	PLATE NO.		
	10

Plate 10 is a photograph of the Sante Fe/ Doolan Chute hydraulic micro model used in this study. The scales were 1inch = 600 feet, or 1:7200 horizontal and 1 inch =100 feet, or 1:1200 vertically for a 6:1 distortion ratio. This distortion supplied the necessary forces required for the simulation of sediment transport conditions similar to the prototype. The bed material was granular plastic urea, Type II, with a specific gravity of 1.23.

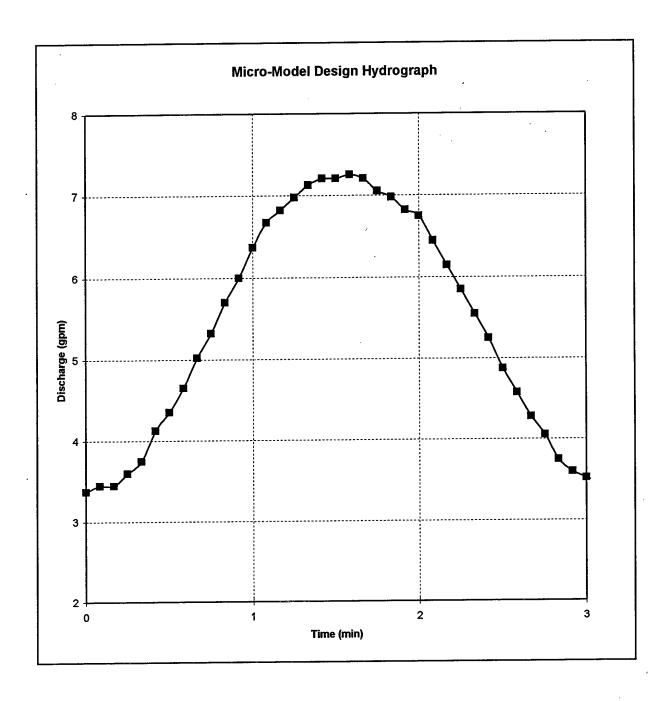
HAH	U.S. ARMY ENGINEER DISTRICT, ST. LOUIS CORPS OF ENGINEERS ST. LOUIS, MISSOURI	
PREPARED BY: R. Helrick CHECKED BY: R. Devinroy	Sante Fe/Doolan Chute Micro Model Study Mississippi River Miles 40 - 35	
	Effective Discharge Hydrograph	
-	PLATE NO.	
	1	1

Plate 11 illustrates the design hydrograph used in this study. This hydrograph served as an effective discharge response (2). Because of the constant variation experienced in the prototype, the effective discharge was used to theoretically analyze the average expected sediment response during any given year. The time increment or duration of the design hydrograph was 3.5 minutes.

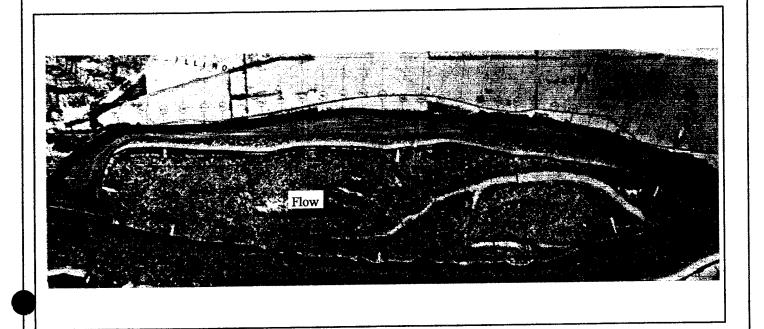
HAH	U.S. ARMY ENGINEER DISTRICT, ST. LOUIS CORPS OF ENGINEERS ST. LOUIS, MISSOURI		
PREPARED BY: R. Hefrick CHECKED BY: R. Dawnroy	Sante Fe/Doolan Chute Micro-Model Study Mississippi River Miles 40 - 35		
	Flow Visualization of Sante Fe Chut	e Base Conditions	
		PLATE NO.	
		15

Plates 14 and 15 are flow visualizations of the main channel and Sante Fe Chute, respectively. Nearly identical patterns were seen in the flow visualization of the base test condition in the micro model as compared to the ice photo on plate 12.

- g. Very little energy or sediment transport potential was observed in Sante Fe Chute, especially in the lower one half of the channel. From flow visualization tests, it became apparent that the main channel backwater influence created this condition at all simulated flow conditions.

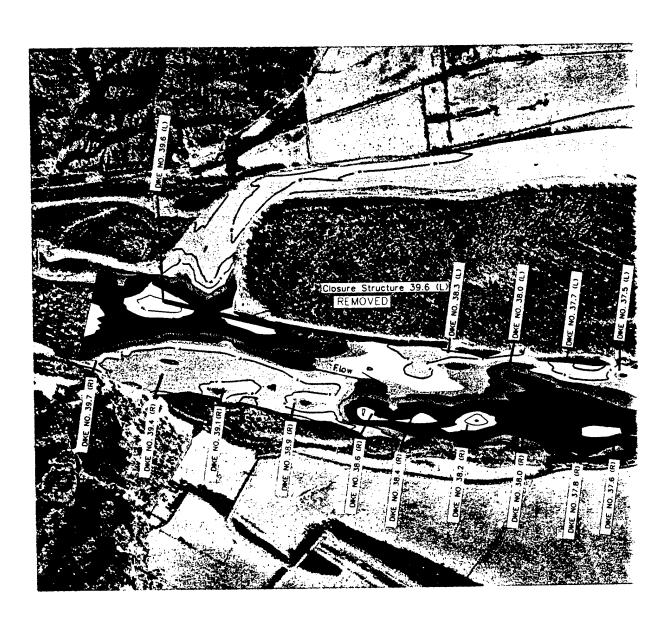
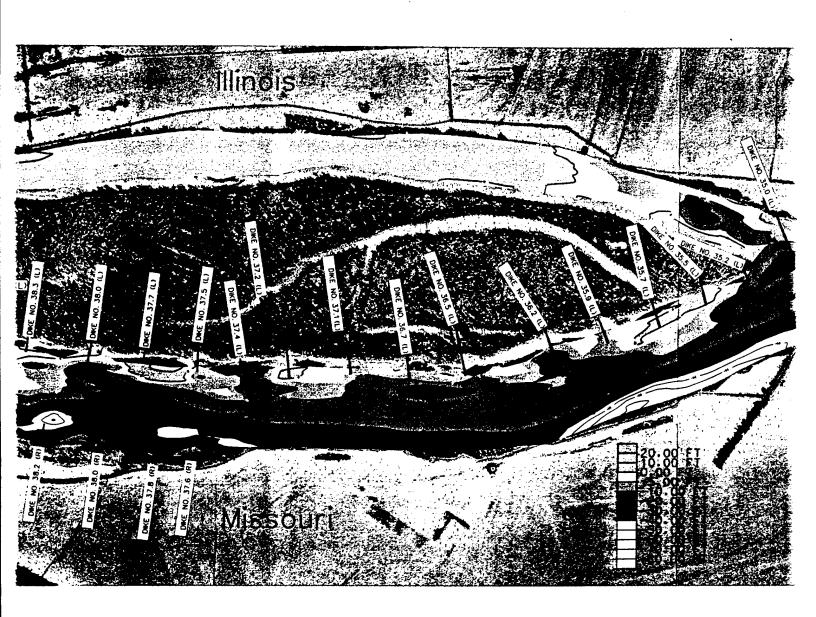
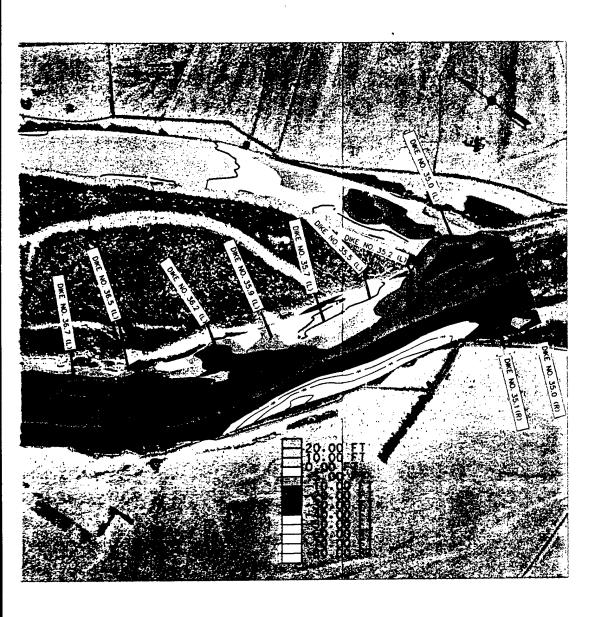
CLOSURE STRUCTURE 39.6(L) REMOVED

Alternative A. Removal of Closure Structure 39.6L. Plate 16 is a plan view contour map of the resultant bed configuration of alternative A. Results of this test indicated that removal of the closure structure caused the downstream navigation channel to shoal excessively (0 to -10 LWRP). The tendency for channel flushing in Sante Fe Chute was non-existent, with some additional sediment actually entering the side channel and filling in the scour hole located near River Mile 39.0.

- Additional sediment allowed into Sante Fe chute by closure structure modification will cause deposition throughout the entire chute and fill in the scour hole that exists near River Mile 39.0.

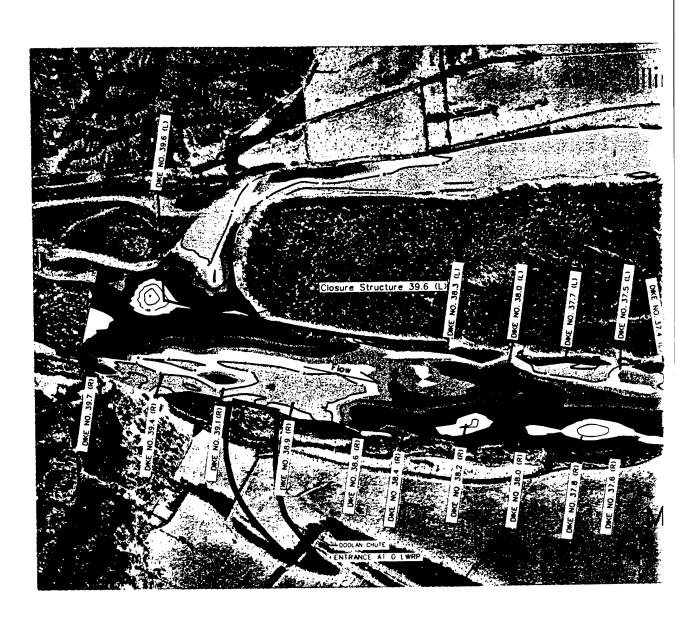
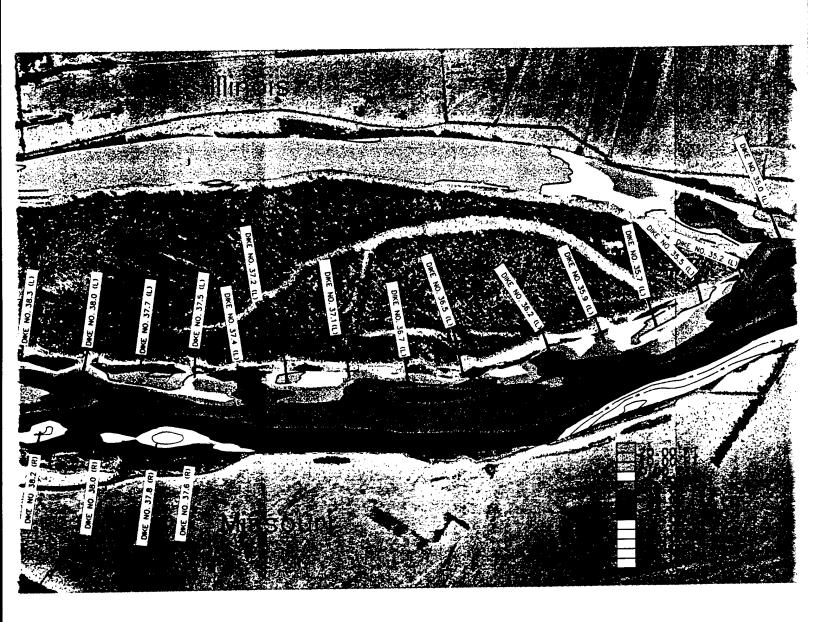
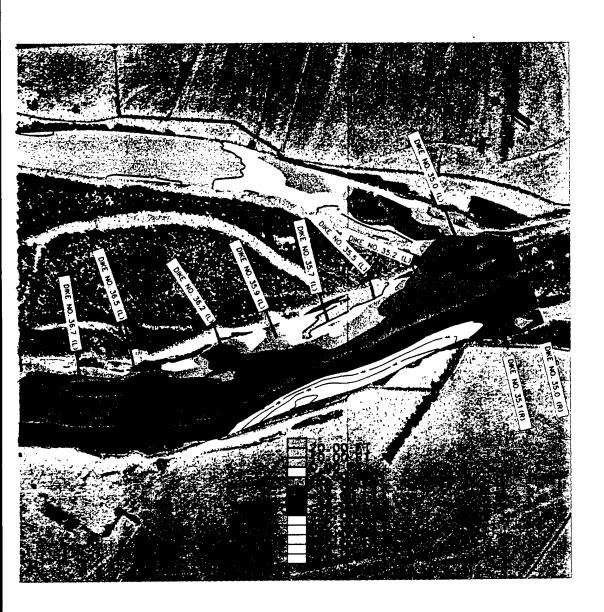
Sante Fe/Doolan Chute Micro Model Study
Mississippi River Miles 40 - 35
ALTERNATIVE H
DOOLAN CHUTE LINKAGE WITH THE MAIN CHANNEL.
ENTRANCE CONDITIONS AT 0 LWRP

Alternative H. Doolan Chute Linkage With the Main Channel, Entrance Conditions at 0 LWRP. Plate 26 is a plan view contour map of the resultant main channel bed configuration for alternative H after 15 hydrographs. Results of this test indicated a tendency for shoaling in the downstream crossing of the main channel.

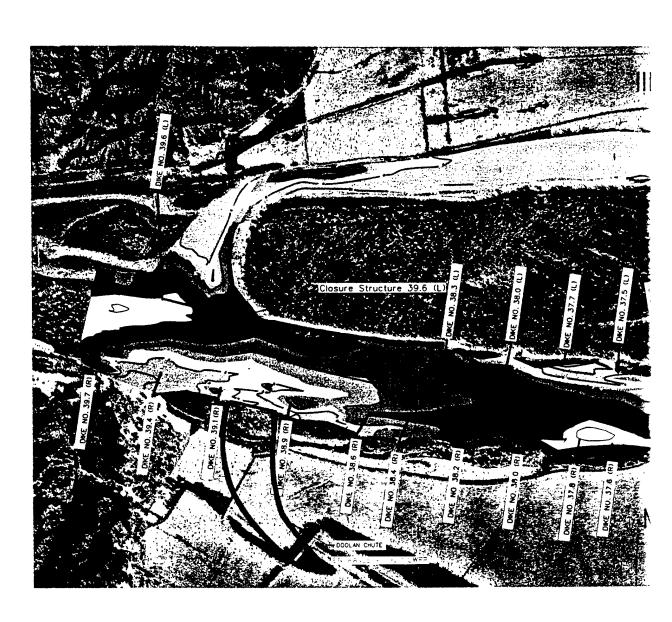
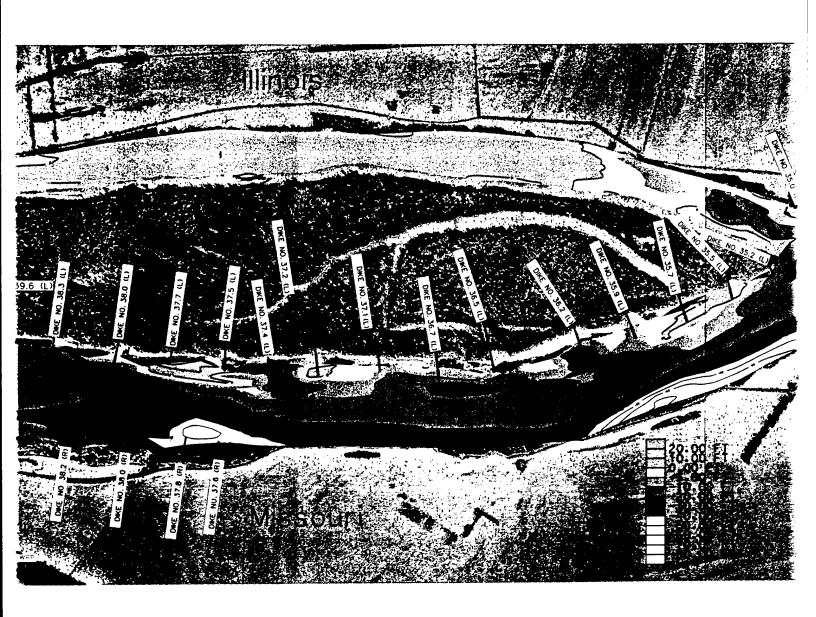
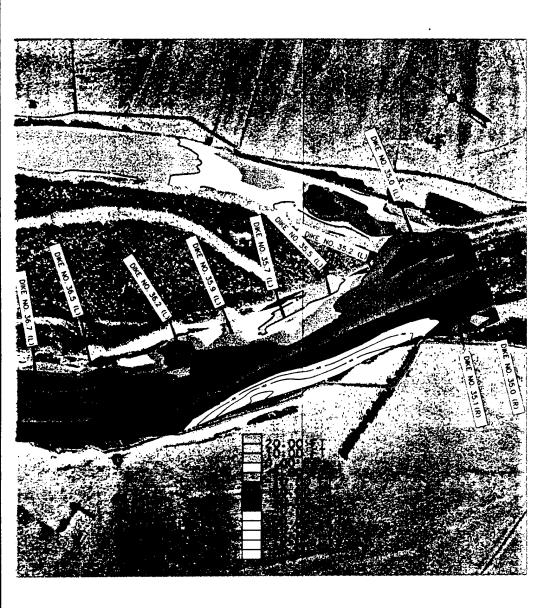
Sante Fe/Doolan Chute Micro Model Study
Mississippi River Miles 40 - 35
AL TERNATIVE I
DOOLAN CHUTE LINKAGE WITH THE MAIN CHANNEL.
ENTRANCE CONDITIONS AT -20 LWRP

Alternative I. Doolan Chute Linkage With the Main Channel, Entrance Conditions at +20 LWRP. A closure structure was placed at the entrance of Doolan Chute to limit flow through the chute to stages only above +20 LWRP. Plate 27 is a plan view contour map of the resultant main channel bed configuration for alternative I. This alternative did not cause shoaling in the downstream crossing of the navigation channel. Bed stability in Doolan chute required 7 more hydrographs to develop than alternative H.
